**Flood Control Project Maintenance
Levee Inspections**
LMA District Cover Sheet
Spring 2019 Levee Inspection Results

Reclamation District No. 0554 Walnut Grove

Spring 2019 Levee Inspection Results

Waterway			Bank	Unit Miles
Unit No. 01 Sacramento River			Left	1.13
	Spring (March - May)	Summer (June - August)	(September - November) Fall	Winter (December - February)
Unit Maintenance Rating (Fall Only)				
Date of Inspection	3/15/2019 - 3/15/2019			
DWR Inspector	David Julian			
Accompanied By

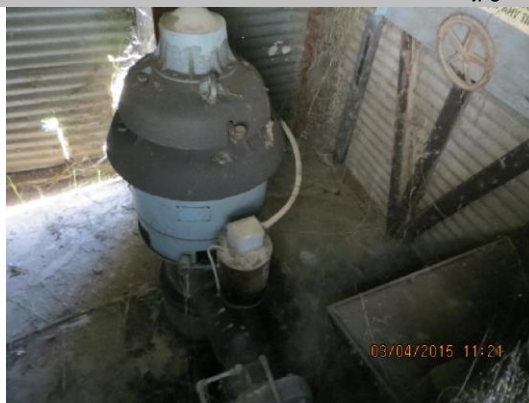
Photo 2 of 3 : UCIP_SP_2019_43726_73281.jpg

Pump over well inside pumphouse on LS toe.

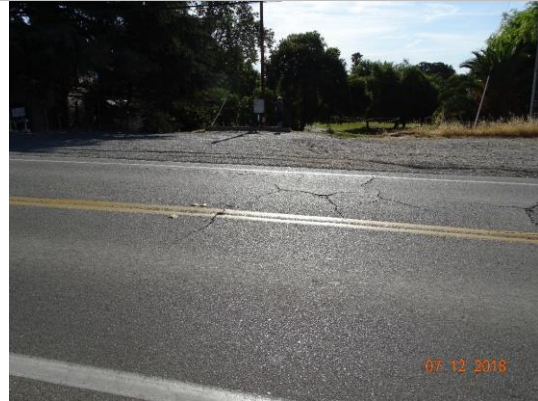
Photo 1 of 3 : UCIP_SP_2019_53405_77590.jpg

Comment Code					
Inspector Comment					
FS_ID:53405 DS_ID:20915 EP_NO: 3360 Repair Type: Non-Urgent Crossing Status: Not Found UCIP Comments: 07/12/2018 No gas line markers at the crossing found. Need to contact PG&E. Crossing has been downgraded to "Non-Urgent" due to reclassification of gas lines. (O.Yakimov-DWR UCIP)7/25/2016 Coordinated with District Engineer, Gilbert Labrie with DCC Engineering. He will investigate the pipe and coordinate with PG&E to find out additional information regarding the fate of the pipe. (DWR UCIP - omagana)3/04/2015 No markers found. Need to contact owner to determine status of crossing. Recommend having owner install markers per CVFPB Title 23 for active pressure line. Owner will need to coordinate with CVFPB. (DWR UCIP - omagana) FIELD_STRUCT_DESC: Gas line along and through the levee, 3.5 feet below the crown. (gas line authorized under Permit No. 3360, 1962 - Pacific Gas and Electric Company [PG&E]) FS Date: 7/12/2018 7:28:04 AM

View of levee crown at the crossing toward LS.

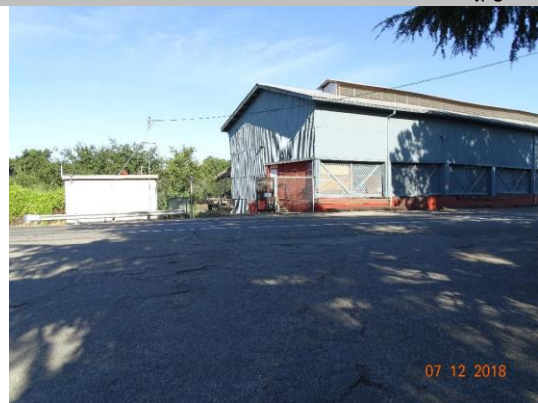
Photo 2 of 3 : UCIP_SP_2019_53405_77591.jpg

View of levee crown at the crossing toward WS.

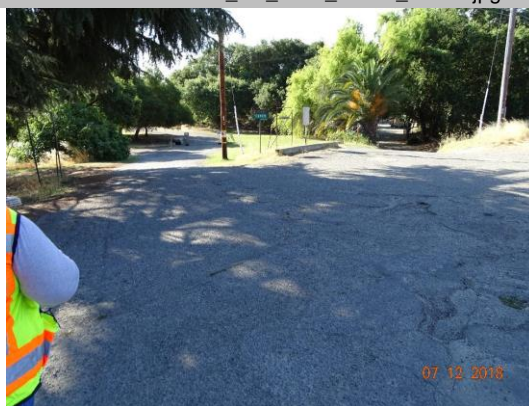
Photo 3 of 3 : UCIP_SP_2019_53405_77592.jpg

Comment Code						
Inspector Comment						
FS_ID:53405 DS_ID:20915 EP_NO: 3360 Repair Type: Non-Urgent Crossing Status: Not Found UCIP Comments: 07/12/2018 No gas line markers at the crossing found. Need to contact PG&E. Crossing has been downgraded to "Non-Urgent" due to reclassification of gas lines. (O.Yakimov-DWR UCIP)7/25/2016 Coordinated with District Engineer, Gilbert Labrie with DCC Engineering. He will investigate the pipe and coordinate with PG&E to find out additional information regarding the fate of the pipe. (DWR UCIP - omagana)3/04/2015 No markers found. Need to contact owner to determine status of crossing. Recommend having owner install markers per CVFPB Title 23 for active pressure line. Owner will need to coordinate with CVFPB. (DWR UCIP - omagana) FIELD_STRUCT_DESC: Gas line along and through the levee, 3.5 feet below the crown. (gas line authorized under Permit No. 3360, 1962 - Pacific Gas and Electric Company [PG&E]) FS Date: 7/12/2018 7:28:04 AM

View of LS at the crossing.

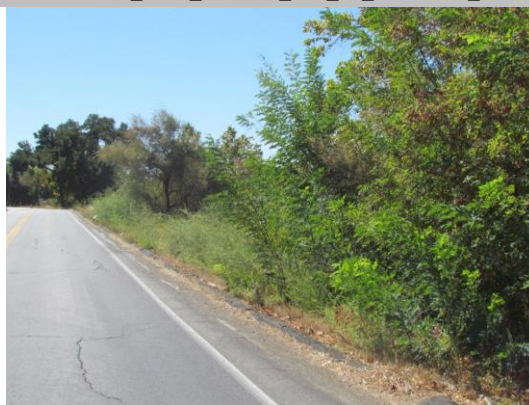
Photo 1 of 1 : SP_2019_RD0554_176_31_20190311_00010.jpg

LM Start	0.02	Rating **	M	Issue No.	31
LM End	0.17	Issue Type +	Ma	Location *	WS
Category	Earthen Levee			GPS Latitude/Longitude	
				Start	End
Item	Vegetation			38.249449 °	38.247375 °
				-121.510017 °	-121.509990 °
DWR ID	DWR_RD0554_01_f_2016_31				
Comment Code					
V2 : Remove the wild growth other than native grasses from the levee slopes.					
Inspector Comment					
Remove/reduce wild growth on the waterside to 20 feet from the crown.

Looking downstream waterside levee slope from levee mile 0.08-0.30.

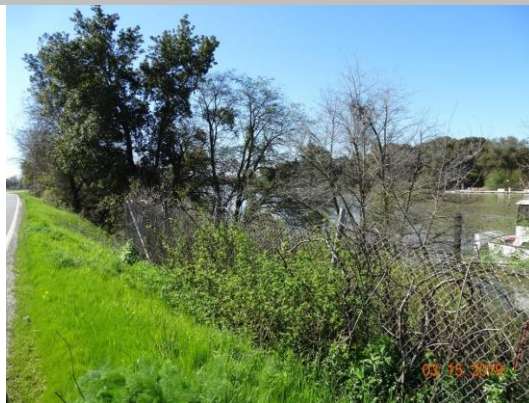
Photo 1 of 1 : SP_2019_RD0554_176_26_20190320_00052.jpg

View looking downstream at chainlink fence on the waterside slope (Spring 2019).

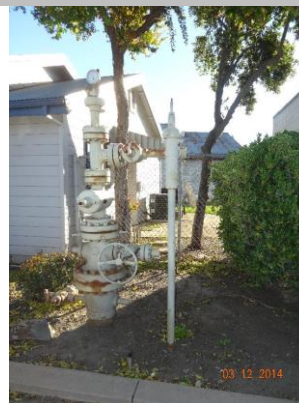
Photo 1 of 1 : UCIP_SP_2019_42146_58463.jpg

LM Start	0.08	Rating **	U	Issue No.	40
LM End	0.08	Issue Type +	En	Location *	
Category	Supplemental			GPS Latitude/Longitude	
				Start	End
Item	DWR UCIP Field Study			38.248643 °	38.248643 °
				-121.509850 °	-121.509850 °
DWR ID	20946				
Comment Code					
Inspector Comment					
FS_ID:42146 DS_ID:20946 EP_NO: 5607 Repair Type: Urgent Crossing Status: Indicator Found UCIP Comments: No markers. Valves abandoned on landward side--need to contact owner to determine status of crossing. FIELD_STRUCT_DESC: Abandoned three 4-inch steel petroleum pipes through the levee, 22.5 feet below the crown. Pipes placed in 8-inch pipe casing through the levee and plugged with concrete. Abandoned under Permit No. 5607 (1966). FS Date: 3/12/2014

Valves located on landward side.

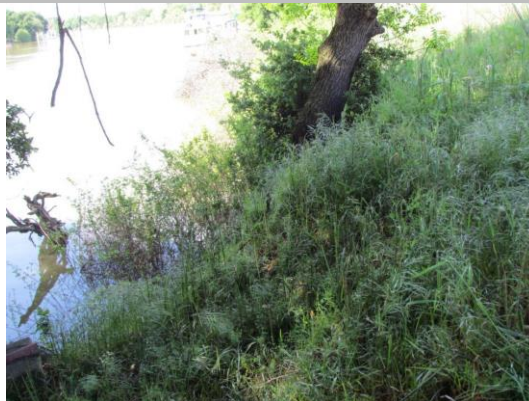
Photo 1 of 1 : SP_2019_RD0554_176_11_20190311_00001.jpg

LM Start	0.10	Rating **	M	Issue No.	11
LM End	0.10	Issue Type +	Ma	Location *	WS
Category	Earthen Levee			GPS Latitude/Longitude	
				Start	End
Item	Erosion / Bank Caving			38.248262 °	38.248262 °
				-121.509901 °	-121.509901 °
DWR ID	DWR_RD0554_01_s_2014_11				
Comment Code					
E1 : Note and monitor erosion site.					
Inspector Comment					
This is not a new erosion site, repairs are needed. One tree has fallen into the Sac River at the erosion site. This site can be seen better from the river by boat. The wild grapes block the view from the waterside shoulder looking down the slope. Rated as M because it is an oversized levee section.

RD 554 Waterside levee slope erosion into the bank, the wild vegetation growth blocks the view.

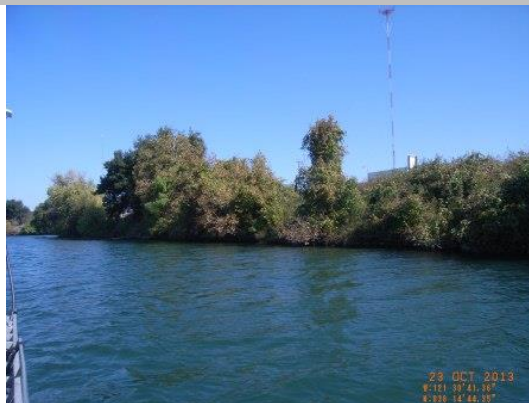
Photo 1 of 2 : SP_2019_RD0554_176_24_20190311_00005.jpg

LM Start	0.26	Rating **	M	Issue No.	24
LM End	0.36	Issue Type +	Ma	Location *	WS
Category	Supplemental			GPS Latitude/Longitude	
				Start	End
Item	2017 USACE Erosion Survey, DRAFT			38.246222 °	38.245017 °
				-121.510878 °	-121.511740 °
DWR ID	DWR_RD0554_01_f_2018_24				
Comment Code					
Inspector Comment					
2017 Site ID: SAC 27.0 L					
Status: Eroding					
2017 Field Notes: Minor new erosion at toe.					
Site History: 2009 - Tension cracks on road on top of levee. Erosion into the levee slope and mass failure. 2013 - Short vertical sections at bank toe.

USACE 2013 Photo #1

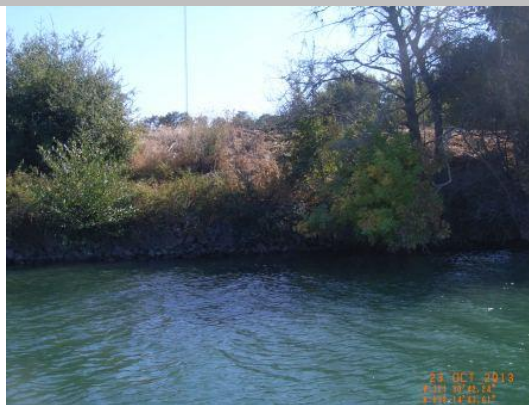
Photo 2 of 2 : SP_2019_RD0554_176_24_20190311_00006.jpg

USACE 2013 Photo #2

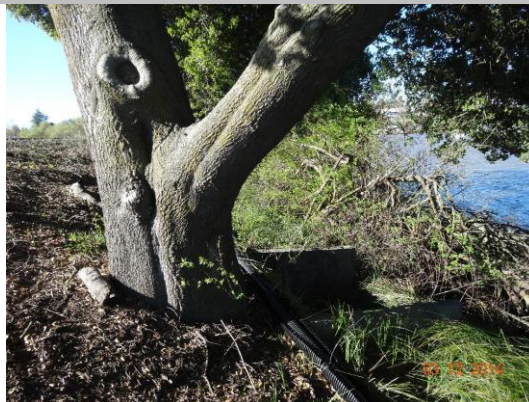
Photo 2 of 3 : UCIP_SP_2019_32018_58468.jpg

Concrete vault located on waterward side. Site is a erosion repair site.

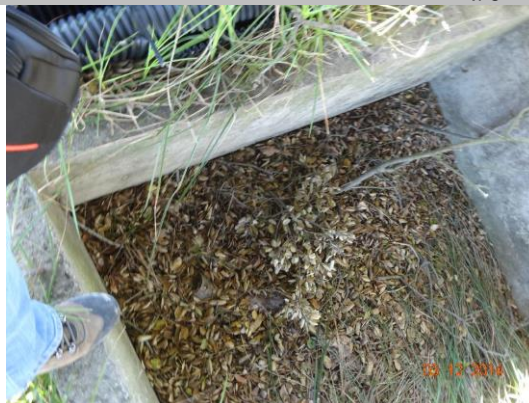
Photo 3 of 3 : UCIP_SP_2019_32018_58467.jpg

Comment Code					
Inspector Comment					
FS_ID:32018 DS_ID:20897 EP_NO: N/A Repair Type: Non-Urgent Crossing Status: Indicator Found UCIP Comments: Unable to determine status of crossing--was crossing removed during erosion repair site in 2007-2009? Need to coordinate with LMA or owner to obtain additional information about crossing. FIELD_STRUCT_DESC: *ABANDONED* 6-inch irrigation pipe of unknown material through the levee, 1.0-foot below the crown. Concrete pump pad on the waterside (WS) slope. [Additional Reference(s): DWR Levee Log, 1983 and 2005. USACE Sacramento O&M Manual Unit No. 111, May 1959, revised 29 Dec 2016, (River Mile [RM] 27.00)] FS Date: 3/12/2014

Concrete face no outlet visible on waterward side.

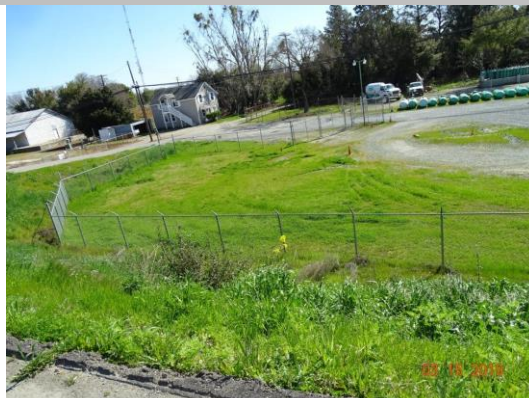
Photo 1 of 1 : SP_2019_RD0554_176_34_20190320_00055.jpg

LM Start	0.27	Rating **	M	Issue No.	34
LM End	0.32	Issue Type +	En	Location *	LS
Category	Earthen Levee			GPS Latitude/Longitude	
				Start	End
Item	Encroachments			38.246065 °	38.245397 °
				-121.510688 °	-121.511168 °
DWR ID	DWR_RD0554_01_s_2019_34				
Comment Code					
FE : Fence					
Inspector Comment					
A fence is located at the landside toe.

View of chainlink fence at the landside toe (Spring 2019).

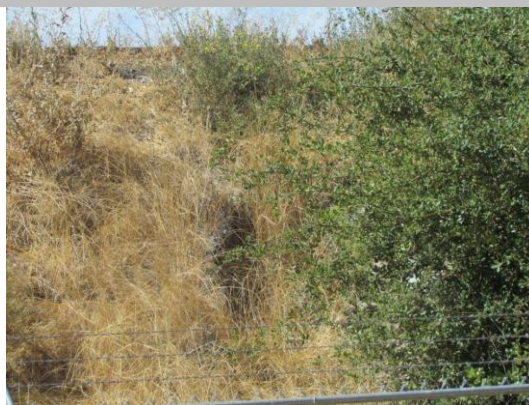
Photo 2 of 3 : SP_2019_RD0554_176_13_20190311_00003.jpg

This erosion site along the landside slope levee 0.32 has been reported and has not been repaired.

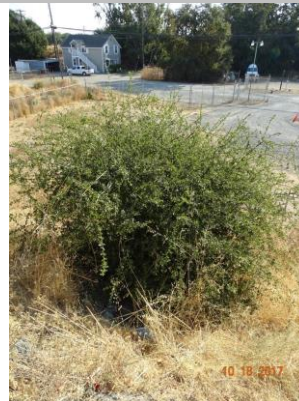
Photo 3 of 3 : SP_2019_RD0554_176_13_20190311_00004.jpg

This erosion is not repaired to date. Large bush growing in eroded gully. Needs repairing.

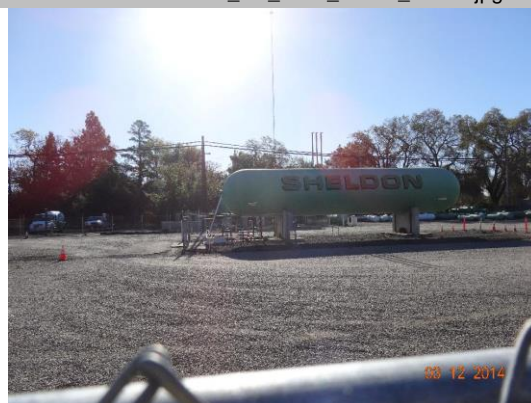
Photo 1 of 1 : UCIP_SP_2019_42143_60800.jpg

LM Start	0.33	Rating **	U	Issue No.	42
LM End	0.33	Issue Type +	En	Location *	
Category	Supplemental			GPS Latitude/Longitude	
				Start	End
Item	DWR UCIP Field Study			38.245295 °	38.245295 °
				-121.511274 °	-121.511274 °
DWR ID	20922				
Comment Code					
Inspector Comment					
FS_ID:42143 DS_ID:20922 EP_NO: N/A Repair Type: Urgent Crossing Status: Indicator Found UCIP Comments: No markers found. Need to contact owner to determine status of crossing. Unable to confirm if crossings are still active or if they cross levee. FIELD_STRUCT_DESC: 1 of 3: 3-inch steel fuel line through the levee, 2.7 feet below the crown. (USACE-1959). This entry matches the Drainage or Irrigation Structure referenced in O&M manual (RM 27.20). FS Date: 3/12/2014

Tank found on landward side.

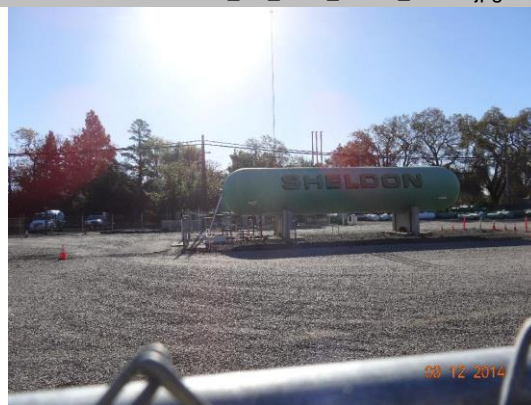
Photo 1 of 1 : UCIP_SP_2019_42144_60801.jpg

LM Start	0.33	Rating **	U	Issue No.	43
LM End	0.33	Issue Type +	En	Location *	
Category	Supplemental			GPS Latitude/Longitude	
				Start	End
Item	DWR UCIP Field Study			38.245295 °	38.245295 °
				-121.511274 °	-121.511274 °
DWR ID	20932				
Comment Code					
Inspector Comment					
FS_ID:42144 DS_ID:20932 EP_NO: N/A Repair Type: Urgent Crossing Status: Indicator Found UCIP Comments: No markers found. Need to contact owner to determine status of crossing. Unable to confirm if crossings are still active or if they cross levee. FIELD_STRUCT_DESC: 2 of 3: 3-inch steel fuel line through the levee, 2.7 feet below the crown. (USACE-1959). This entry matches the Drainage or Irrigation Structure referenced in O&M manual (RM 27.20). FS Date: 3/12/2014

Fuel tank located on landward side.

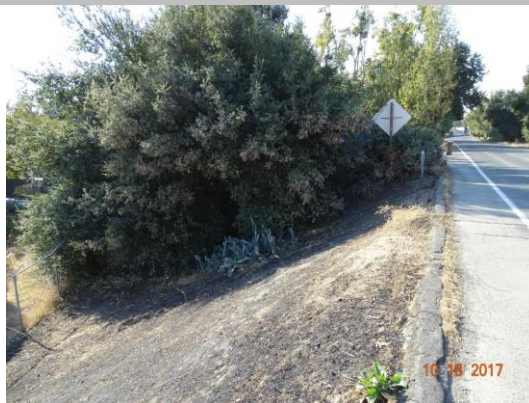
Photo 1 of 1 : SP_2019_RD0554_176_29_20190311_00008.jpg

View of cactus and trees on the landside slope and toe.

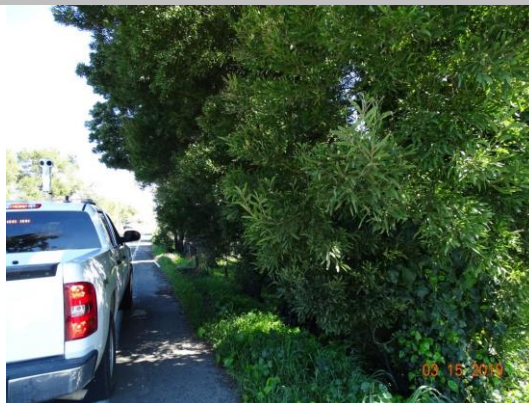
Photo 1 of 1 : SP_2019_RD0554_176_33_20190320_00054.jpg

View looking upstream at landscaping on the landside shoulder (Spring 2019).

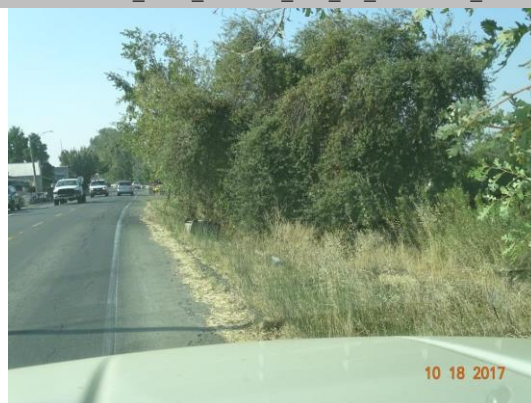
Photo 1 of 1 : SP_2019_RD0554_176_32_20190311_00011.jpg

View of waterside vegetation

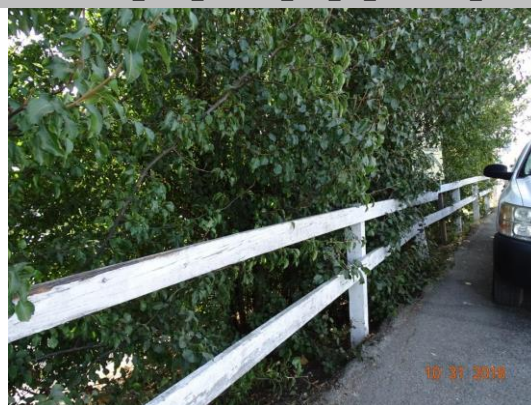
Photo 1 of 1 : SP_2019_RD0554_176_25_20190311_00007.jpg

LM Start	0.58	Rating **	U	Issue No.	25
LM End	0.58	Issue Type +	Ma	Location *	LS
Category	Earthen Levee			GPS Latitude/Longitude	
				Start	End
Item	Trim / Thin Trees			38.242268 °	38.242268 °
				-121.513802 °	-121.513802 °
DWR ID	DWR_RD0554_01_f_2018_25				
Comment Code					
T2 : Thin trees to allow visibility of the ground and room to flood fight.					
Inspector Comment

View of thick trees on the landside slope (October 2018)

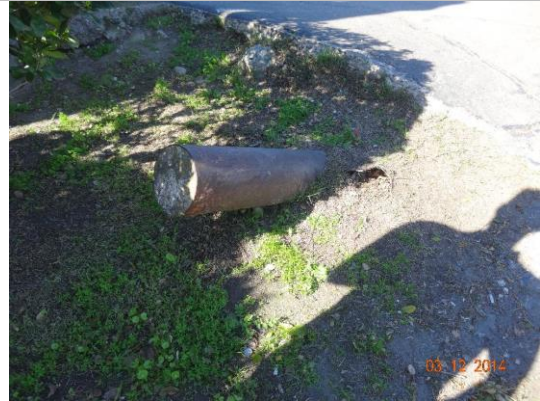
Photo 1 of 1 : UCIP_SP_2019_32020_58473.jpg

Comment Code					
Inspector Comment					
FS_ID:32020 DS_ID:20912 EP_NO: 11154 Repair Type: Non-Urgent Crossing Status: Indicator Found UCIP Comments: Unable to confirm if this pipe section is the same one listed under 11154. Need to contact owner to determine status and obtain additional information about crossing. FIELD_STRUCT_DESC: *ABANDONED* 8-inch pipe of unknown material or purpsoe through the levee, 9.8 feet below the crown. Pump on landside (LS) toe. (8-inch pipe retained under Automatic Board Order (ABO) issued as Permit No. 11154, 1975 - M.M. & H.L. Brown, two 4-inch [HLM 0.75]) [Additional Reference(s): DWR Levee Log, 1983 and 2005. USACE Sacramento O&M Manual Unit No. 111, May 1959, revised 29 Dec 2016, (River Mile [RM] 26.66)] FS Date: 3/12/2014

Steel pipe filled with concrete visible on landward shoulder.

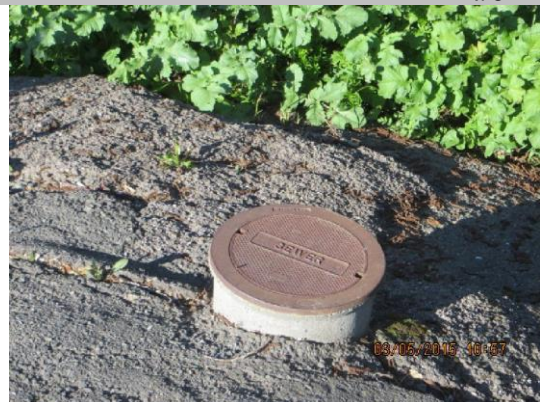
Photo 1 of 3 : UCIP_SP_2019_43805_73320.jpg

LM Start	0.64	Rating **	M	Issue No.	47
LM End	0.64	Issue Type +	En	Location *	
Category	Supplemental			GPS Latitude/Longitude	
				Start	End
Item	DWR UCIP Field Study			38.241550 °	38.241550 °
				-121.514535 °	-121.514535 °
DWR ID	25080				
Comment Code					
Inspector Comment					
FS_ID:43805					
DS_ID:25080					
EP_NO: N/A					
Repair Type: Non-Urgent					
Crossing Status: Found					
UCIP Comments: No permit found. Further investigation required.					
FIELD_STRUCT_DESC: 4-inch cast iron sewer pipe through the levee at an unknown depth. Pipe visible on bridge. Sewer cleanout on waterside (WS) shoulder and cut in pavement visible in roadway. (4-inch pipe authorized under Permit No. 870, 1941 - Shell Oil Company, incorporated)					
FS Date: 3/5/2015

Sewer cleanout on WS shoulder.

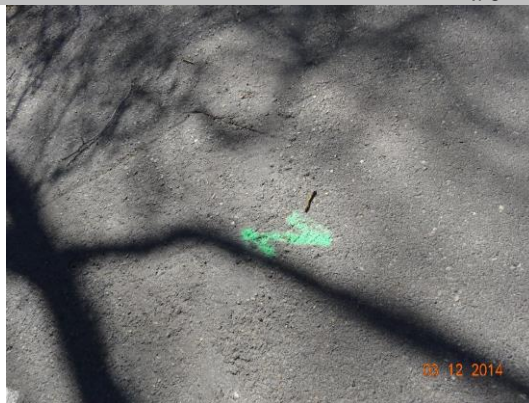
Photo 3 of 3 : UCIP_SP_2019_32021_58477.jpg

View of USA marker on waterward side.

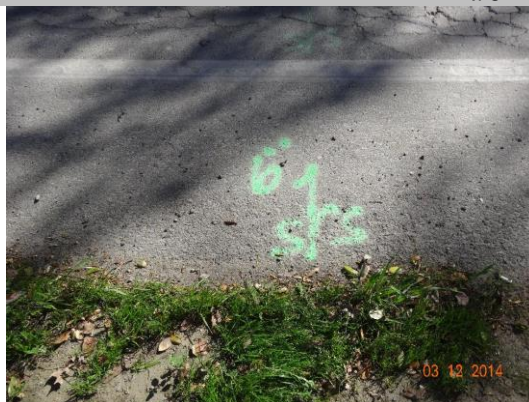
Photo 1 of 3 : UCIP_SP_2019_32022_58480.jpg

LM Start	0.89	Rating **	M	Issue No.	49
LM End	0.89	Issue Type +	En	Location *	
Category	Supplemental			GPS Latitude/Longitude	
				Start	End
Item	DWR UCIP Field Study			38.238595 °	38.238595 °
				-121.516945 °	-121.516945 °
DWR ID	20942				
Comment Code					
Inspector Comment					
FS_ID:32022 DS_ID:20942 EP_NO: N/A Repair Type: Non-Urgent Crossing Status: Indicator Found UCIP Comments: Unable to confirm how many sewer lines cross levee. Desk study shows 2 crossings 4-inch not 6 inch. Need to contact owner to confirm status of crossing. FIELD_STRUCT_DESC: 2 of 2: 4-inch clay sewer pipe through the levee, 10.2 feet below the crown. (USACE-1959). This entry matches the Drainage or Irrigation Structure referenced in O&M manual (RM 26.50). FS Date: 3/12/2014

Underground service alert (USA) marker on waterward shoulder for sewer line.

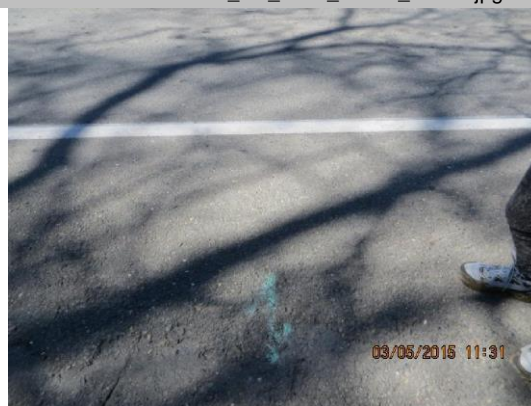
Photo 1 of 3 : UCIP_SP_2019_43804_73323.jpg

USAA SS marking on LS shoulder.

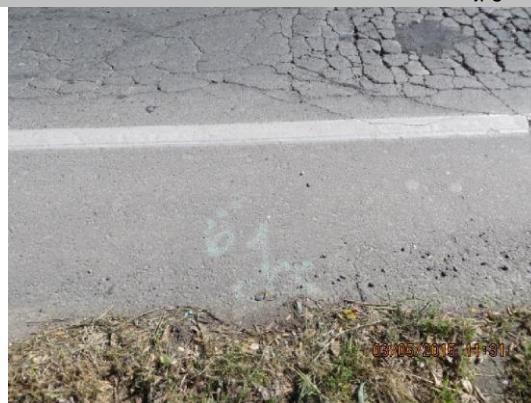
Photo 2 of 3 : UCIP_SP_2019_43804_73324.jpg

USAA SS marking on LS shoulder.

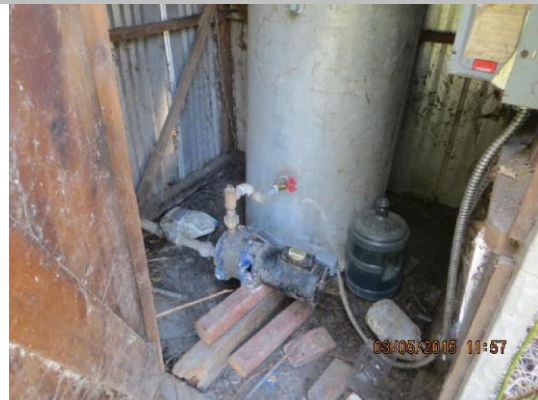
Photo 1 of 3 : UCIP_SP_2019_53406_73243.jpg

Pressurized tank, meter and pump in pumphouse on LS toe.

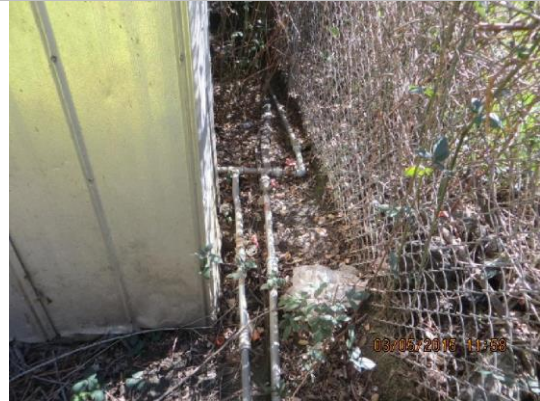
Photo 2 of 3 : UCIP_SP_2019_53406_73244.jpg

A 1-inch and a 1.5-inch galvanized iron drinking water pipe with shutoff valves at pumphouse on LS toe.

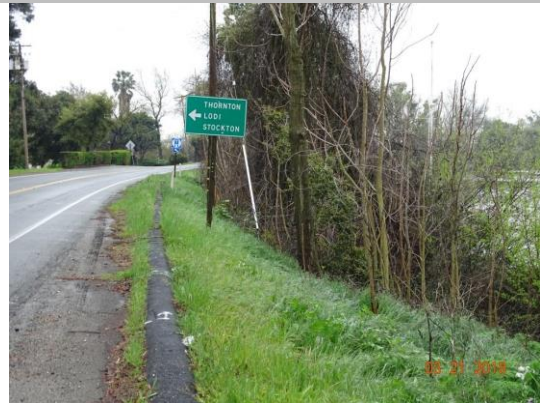
Photo 1 of 1 : SP_2019_RD0554_176_37_20190311_00012.jpg

Trees on waterside should be thinned and trimmed to allow inspection and access.

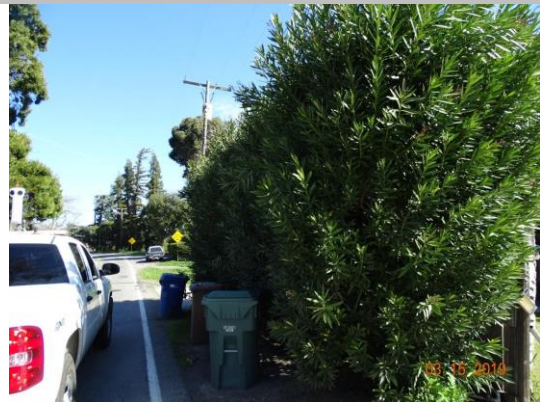
Photo 1 of 1 : SP_2019_RD0554_176_27_20190320_00053.jpg

View looking upstream at landscaping vegetation on the landside shoulder (Spring 2019).

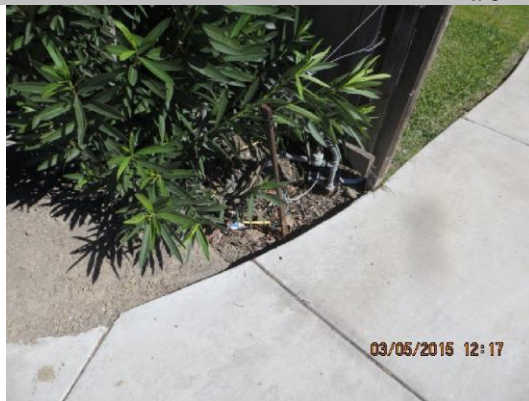
Photo 1 of 3 : UCIP_SP_2019_43810_73328.jpg

Pipes visible at LS shoulder next to driveway.

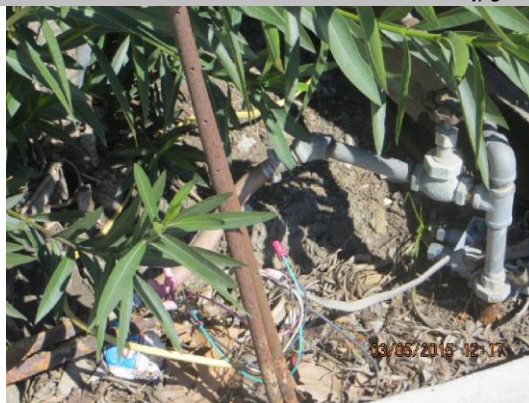
Photo 2 of 3 : UCIP_SP_2019_43810_73329.jpg

Pipes and valves visible on LS shoulder.

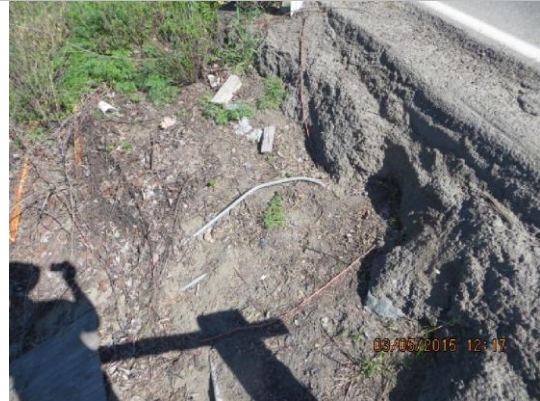
Photo 3 of 3 : UCIP_SP_2019_43810_73330.jpg

Possible outlet on WS shoulder.

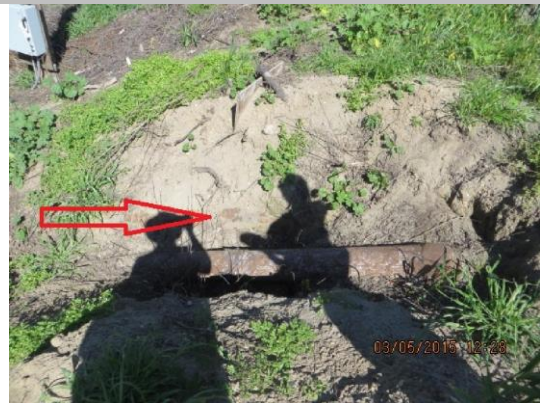
Photo 1 of 1 : UCIP_SP_2019_43747_73286.jpg

Abandoned pipe was exposed on WS slope when a trench was opened to repair the other 8-inch pipe at the site.
